Informal document GRSP-64-41  
(64<sup>th</sup> GRSP, 11-14 December 2018  
agenda item 38(a)(b)(c) and 30(a))

# Pedestrian Safety Research in Japan

MLIT / NTSEL

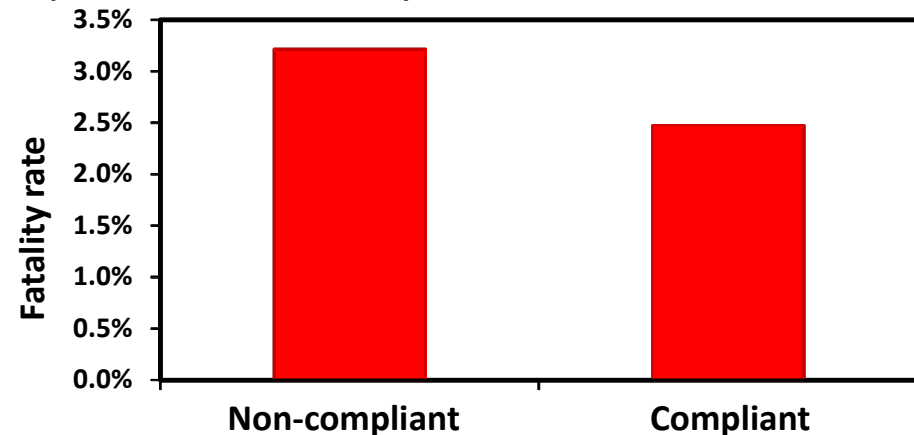
- Macro accident data for 2012 - 2013
- Fatal pedestrian accidents
- M1 category vehicles
- Compliant/non-compliant with the pedestrian safety standard

- Pedestrians accounted for the largest proportion of traffic accident fatalities.
- Pedestrian safety standard is effective for reducing fatalities by traffic accidents .

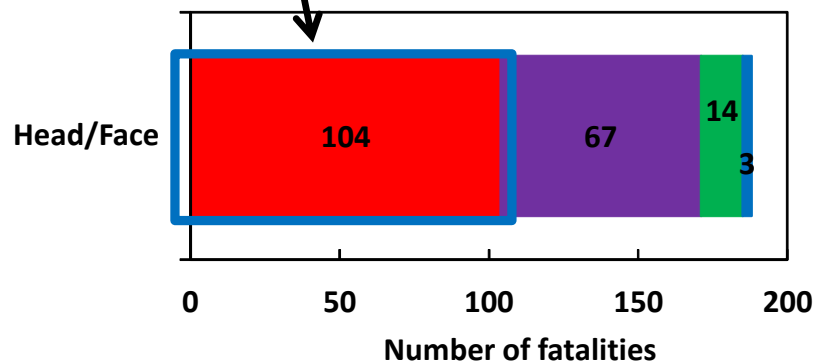
- Macro accident data for 2008-2012
- Pedestrian fatal accidents
- Passenger cars (mini vehicles, sedans, mini vans) compliant with the pedestrian safety standard
- 42% of pedestrian fatal accidents occurred at 40 km/h or below.
- Of the fatal accidents that occurred at under 40km/h, the head/face was the most injured body region, in 51% of the cases.
- In 55% of the fatal accidents, the head/face was hit by external parts of the vehicle.

**There is potential to reduce pedestrian fatalities by further improving the pedestrian safety of vehicles.**

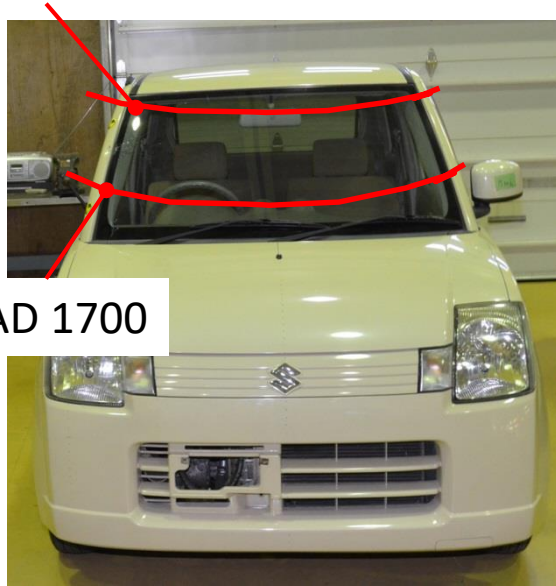
The rearward boundaries of the head impact test area were smaller than WAD 1700, which is the test area using a child head impactor.

→ In almost all adult pedestrian accidents, the pedestrian's head strikes the front window shield glass or A pillar.

- In most cases, WAD of the rear boundary of the head impact test area is less than 1700 and the child head impactor is used. Therefore, in most cases adult pedestrian head protection performance is not evaluated enough in the current regulation.

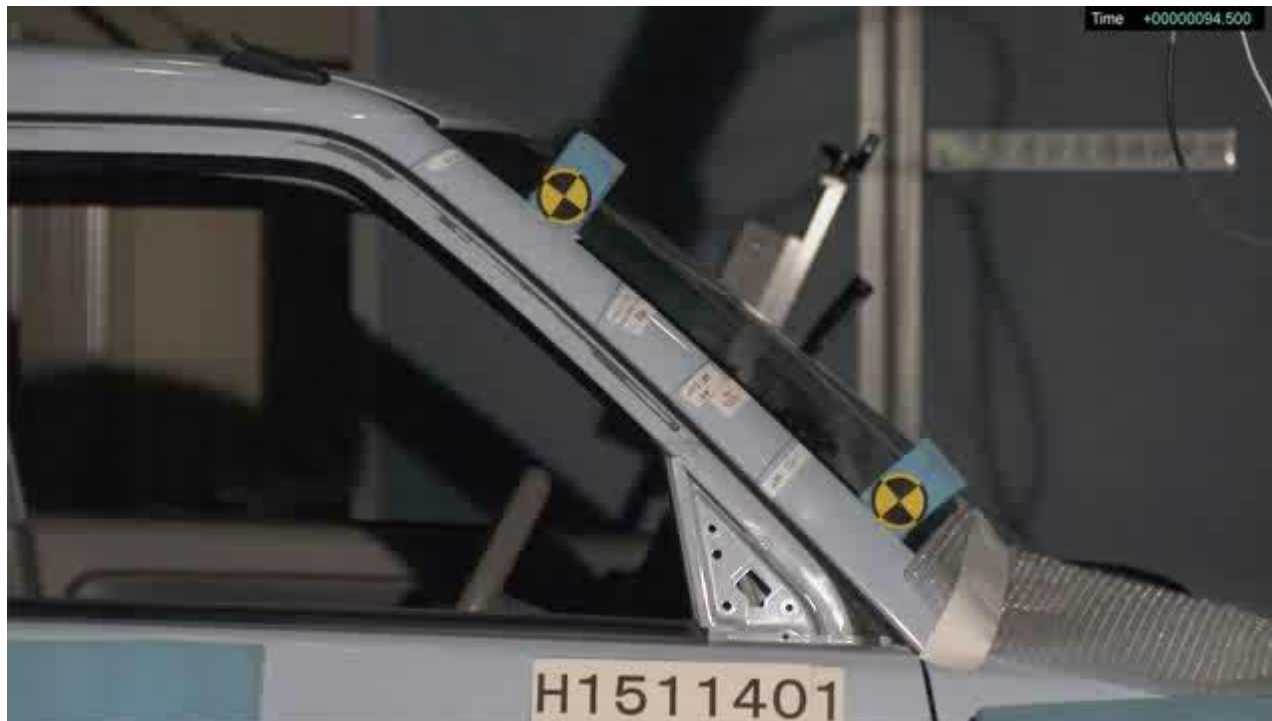
- We conducted pedestrian head protection tests in which the impactor struck the center of the A-pillar (worst-case condition).
- We conducted the tests according to the R127 specifications except for the test area.
- The tested vehicle was compliant with the pedestrian safety standard.
- Several tests were conducted with the same vehicle (the results of the second , third, and all subsequent trials might have been affected by the preceding tests).

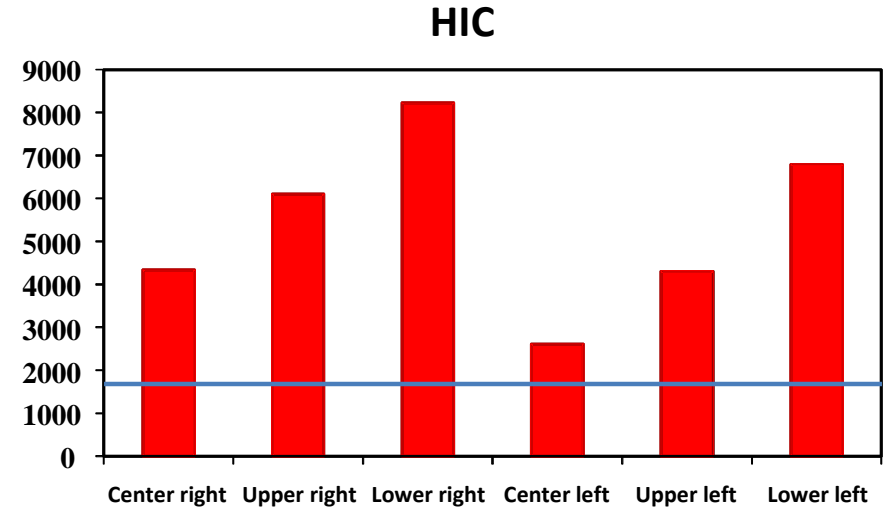
- HIC was above the threshold in all A-pillar tests
- In the J-NCAP test results of the same vehicle, HIC was below the threshold in all test areas.

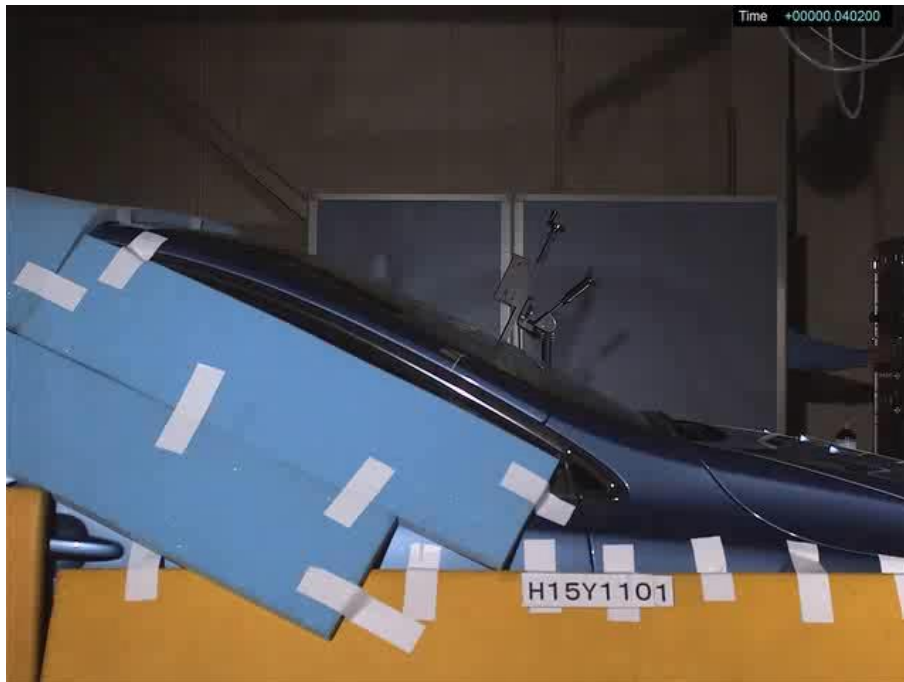
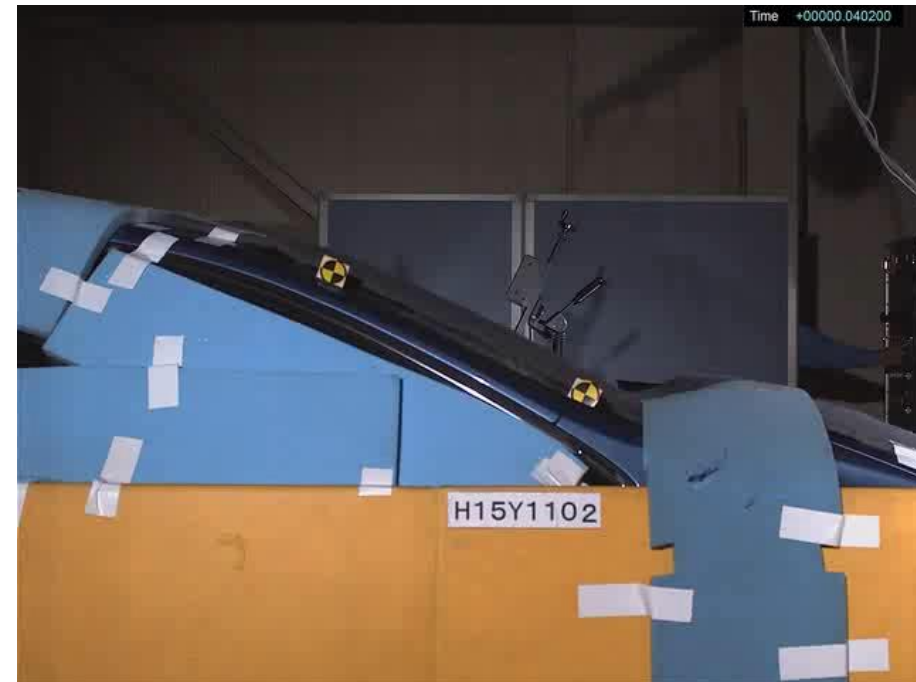
- We conducted pedestrian head protection tests in which the impactor struck the center of the A-pillar (worst-case condition).
- We conducted the tests according to the R127 specifications except for the test area.
- The vehicle was equipped with a pedestrian airbag.
- Tests were conducted with/without the airbag.
- The pedestrian airbag was forcibly deployed at the timing when its performance was sufficient.

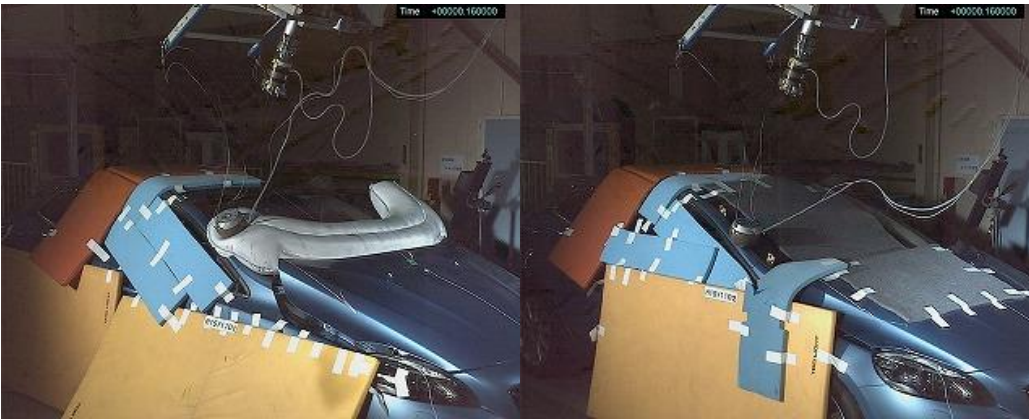
With pedestrian airbag    Without pedestrian airbag

- With the pedestrian airbag, HIC was far below the threshold.
  - Without the airbag, HIC was far above the threshold.
- >The pedestrian airbag is effective for protecting the pedestrian's head in a collision, potentially reducing the number of fatal pedestrian accidents.

- **Pedestrian airbags effectively protect the pedestrian in case the head strikes an A-pillar.**
- **The outermost end of the bumper is out of the bumper test area of UN R127; a test to confirm pedestrian airbag operation using the HYB 2 dummy and Flex leg impactor was performed.**
- **As a result, the pedestrian airbag was deployed.**

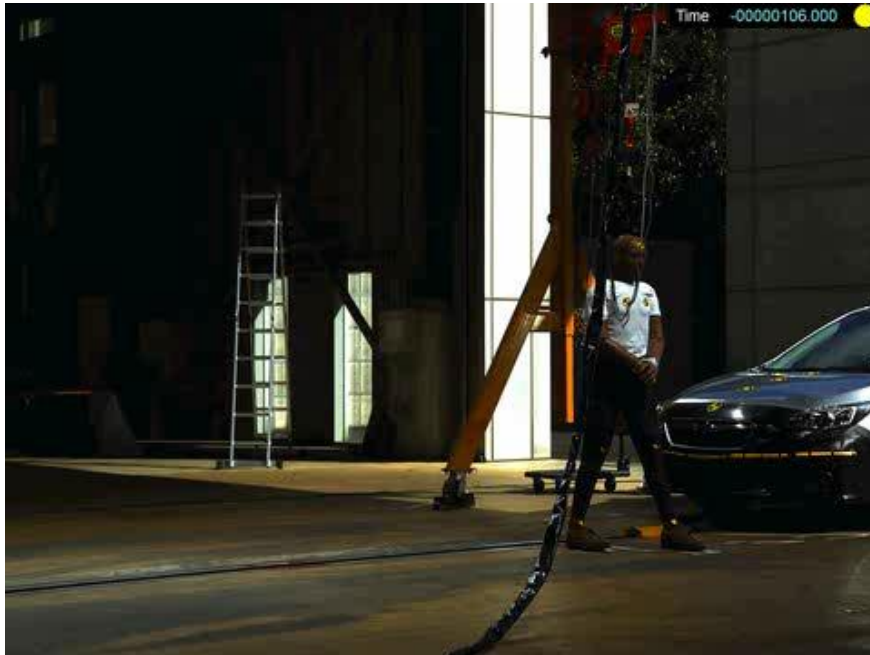
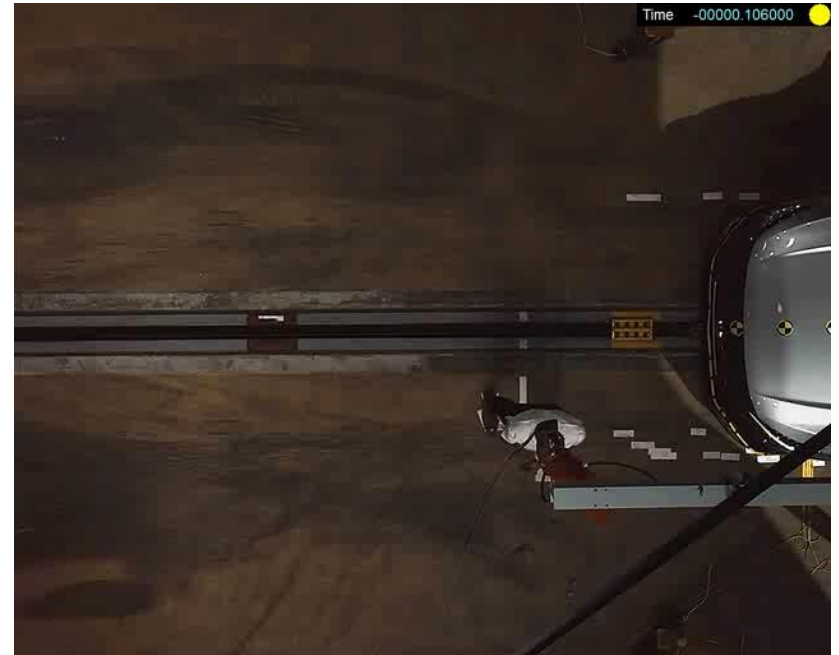
- We plan to confirm that the pedestrian airbag is deployed under the condition that the pedestrian head strikes the A-pillar. In this condition, the pedestrian impact is out of the bumper test area of UN R127.
- We conducted the pedestrian dummy impact test with the vehicle equipped with the pedestrian airbag under the condition that the dummy head struck the A-pillar.
- The pedestrian airbag was deployed under the condition that the pedestrian struck the corner of the vehicle, which was at the outer part of the test area.

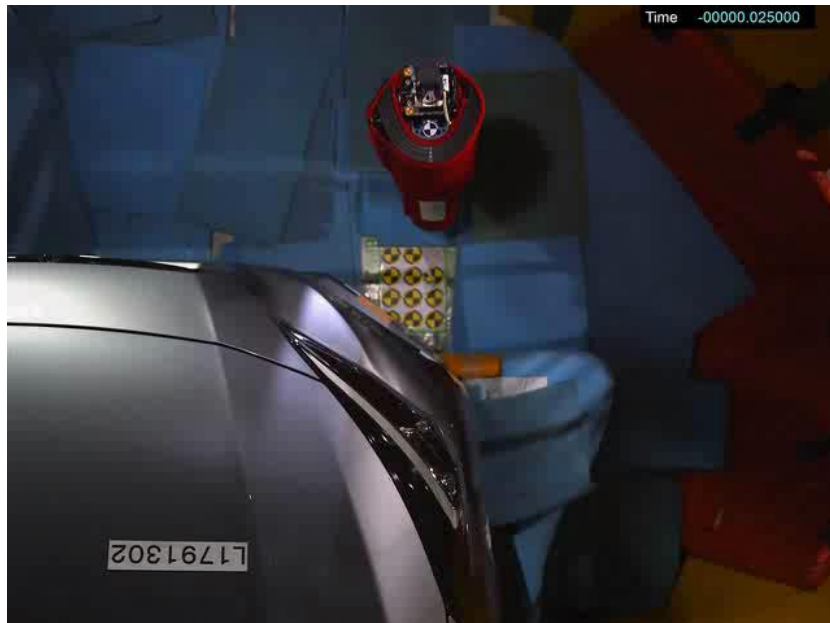
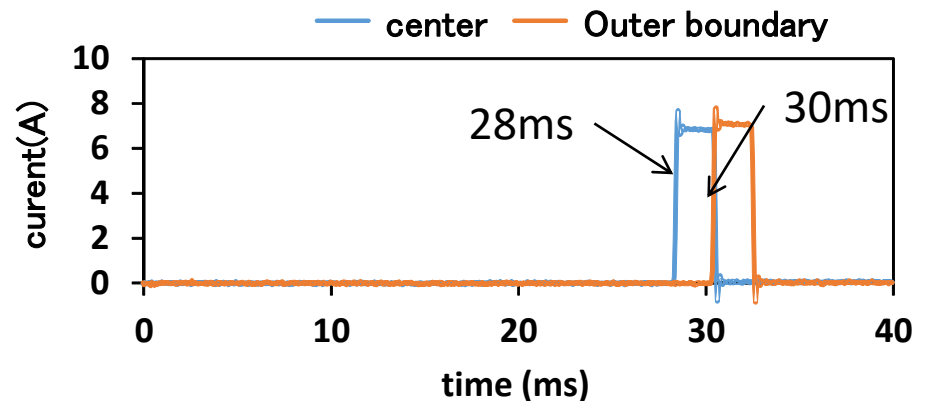
- We plan to confirm that the verification performance test using the Leg Impactor can be done at the outer part of the bumper test area of UN R127.
- We conducted the pedestrian leg protection test with the vehicle equipped the pedestrian airbag at the center of the vehicle and at the outer boundary of the sensing area, which was outside of the bumper test area.
- The timing of the firing signal of the pedestrian airbag was almost the same.
- The verification performance at the outer boundary is almost the same as that at the center, and the verification performance test could be done at the outer area of the bumper test area.

Firing signal of the pedestrian airbag

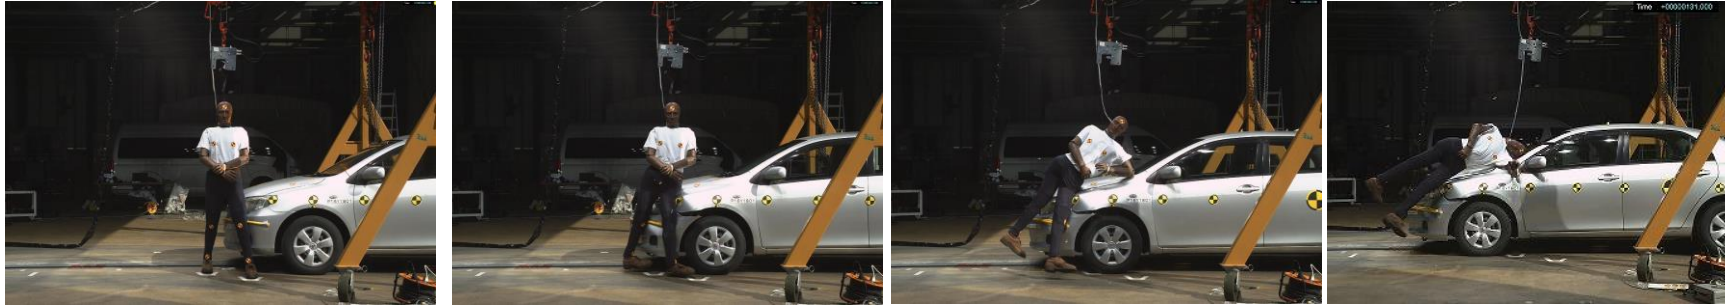
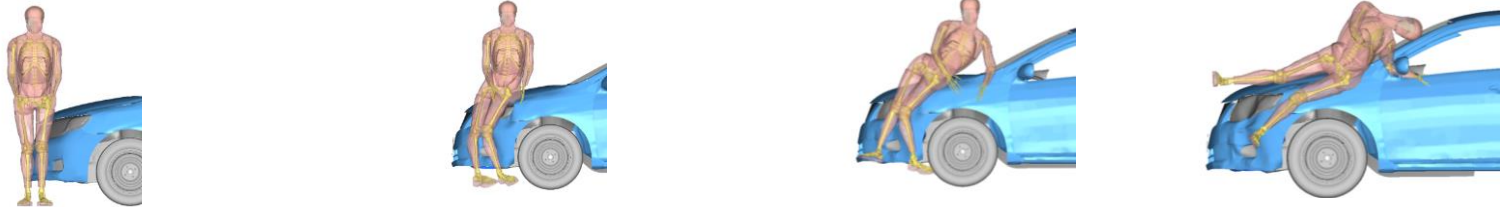
- Impact times were almost the same.
- Impact points were different.

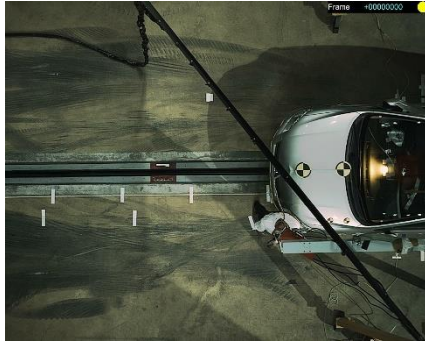
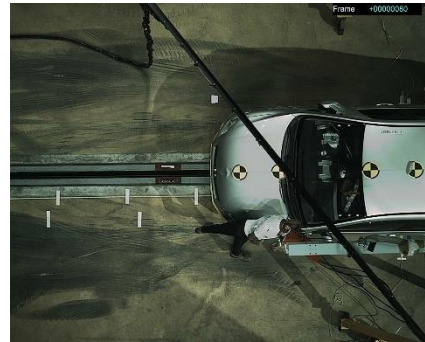
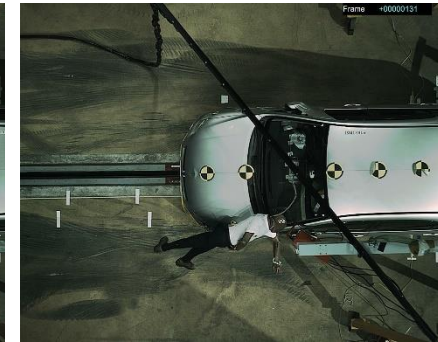
- The pelvis moved further outside in the simulation case than in the test case.

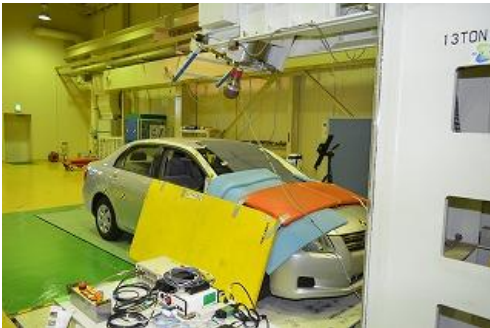
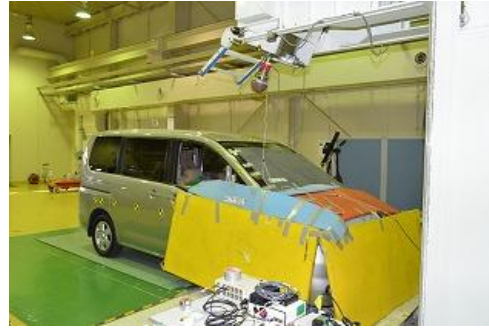
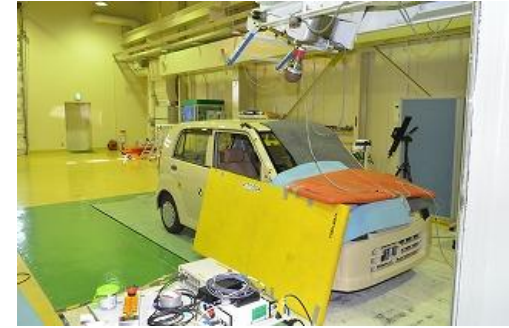
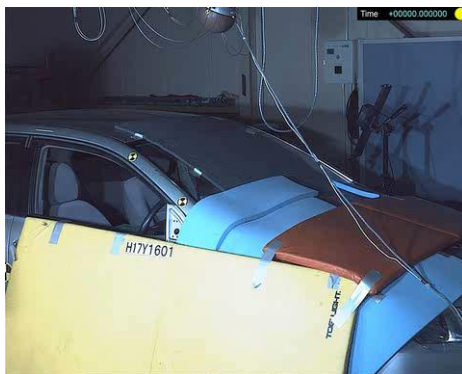
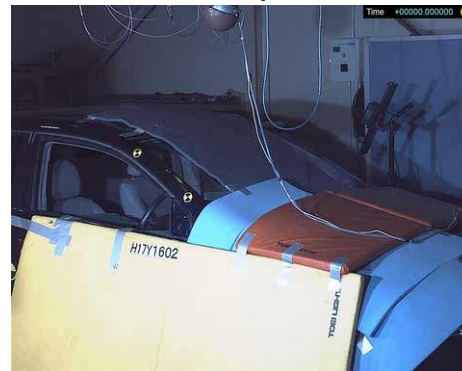
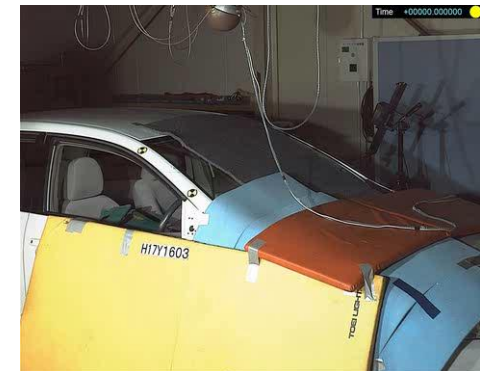
- We conducted the pedestrian head protection tests in which the impactor struck the A-pillar (worst-case condition).
- We conducted the tests according to the R127 specifications except for the test area and test speeds.
- Test speeds were 3 cases, 35 km/h, 25 km/h and 15 km/h.
- The tested vehicles were 3 models, Sedan, Mini-van and Kei-car.

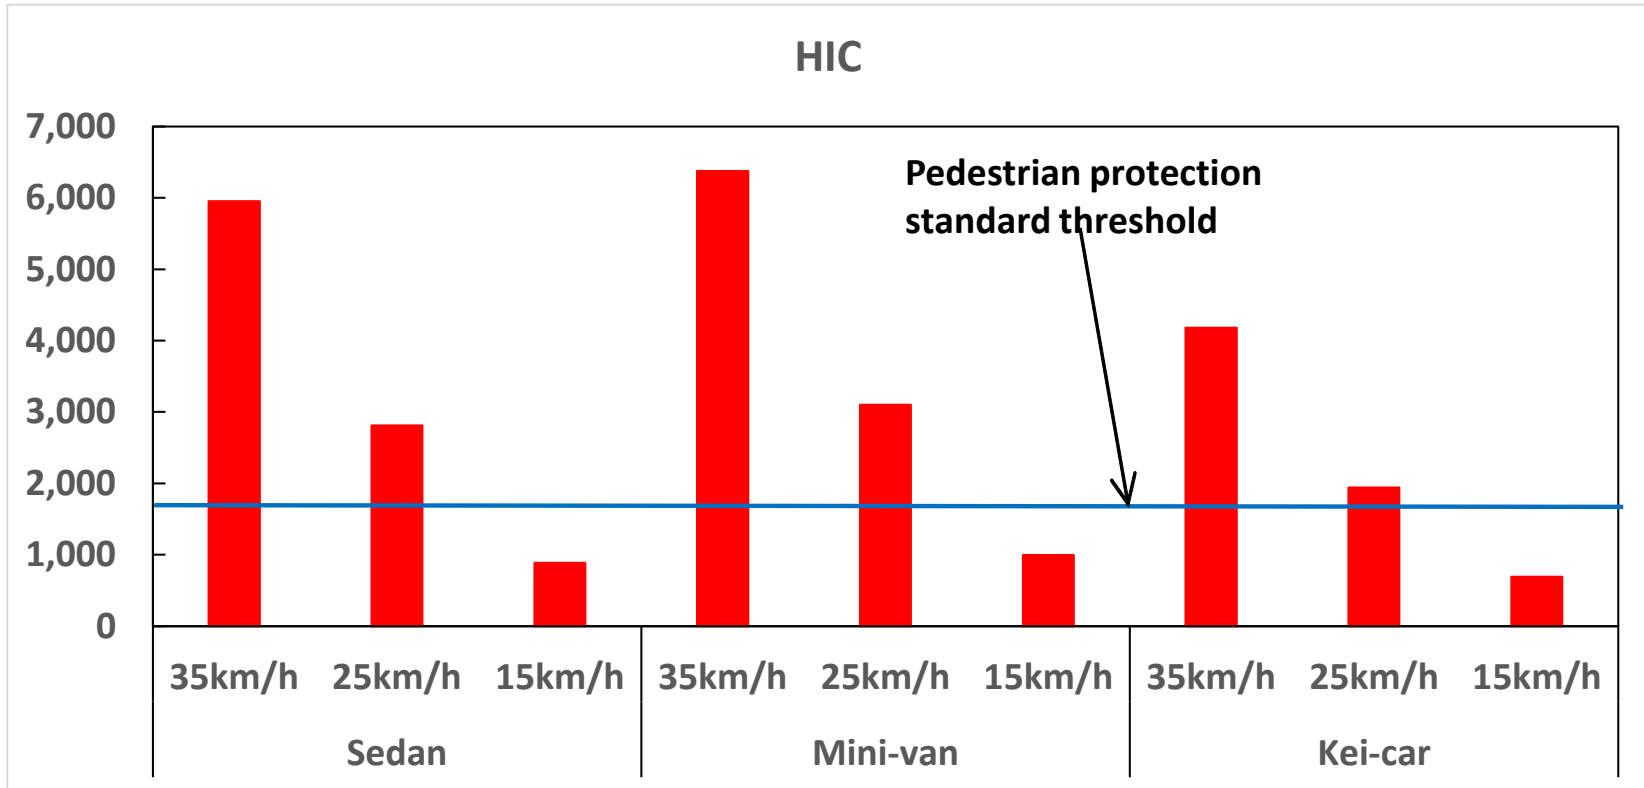
- HICs were above the threshold at test speeds of 35 km/h and 25 km/h.
- HICs were below the threshold at the test speed of 15 km/h.
- HIC at 25 km/h was about half of that at 35 km/h. HIC at 15 km/h was about one third of that at 15 km/h.

- **From the test results, assuming a pedestrian impact accident against the A-pillar at low speed, HICs were below 1000 when the impact speed was 15 km/h and were over 1700 at 25 km/h.**
